**Specific Site Assessment for  
Coal Combustion Waste  
Impoundments at Basin  
Electric Leland Olds  
Generating Station**

**Stanton, North Dakota**

October 2010  
Project 092883

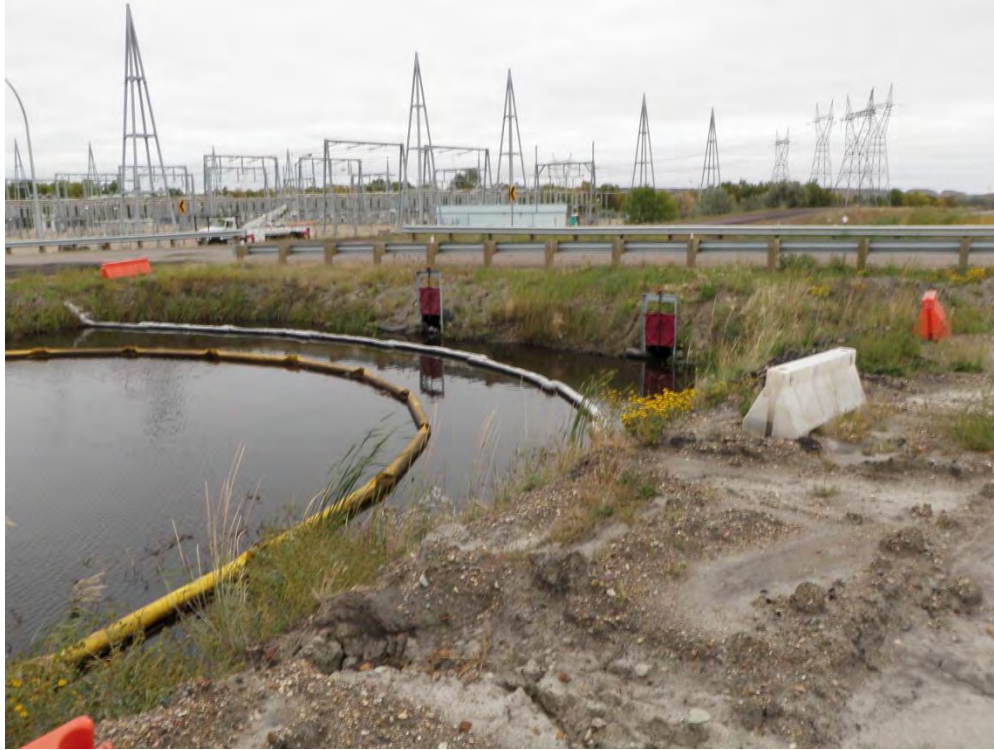
**Photo 1: Coal Yard Stormwater Detention Pond, showing gates leading to Drainage Ditch.**

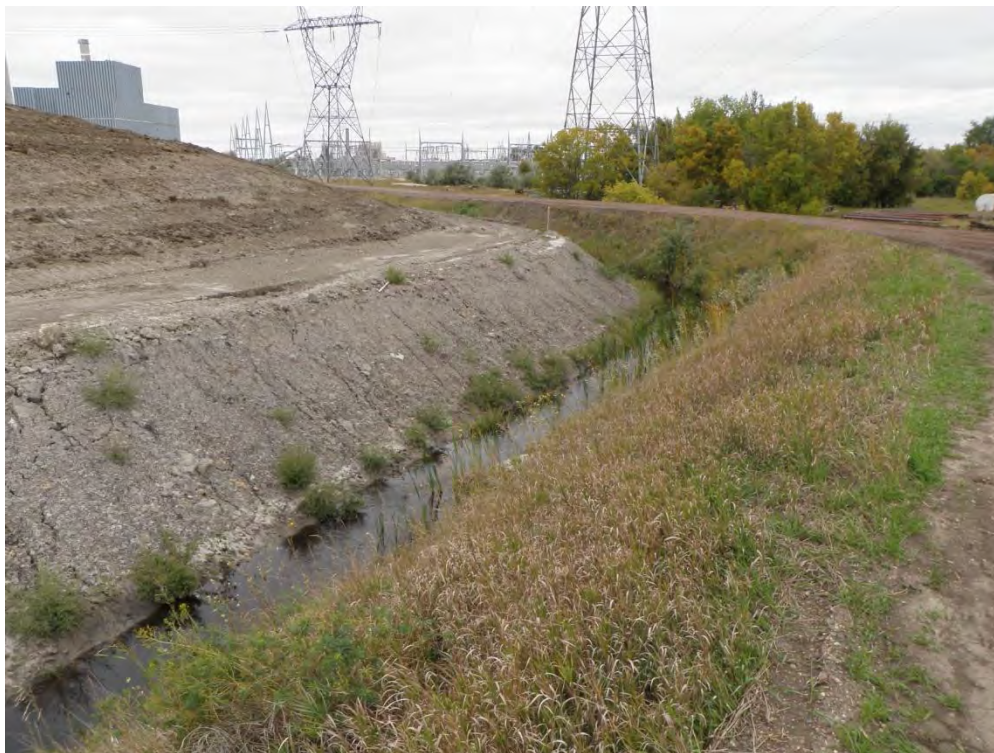
- The three CCW impoundments were generally observed to be in good condition in the field assessment.
- There is minor erosion of the north dike of Ash Pond #1 and currently does not have erosion protection installed.

**Photo 2: Coal Yard Drainage Ditch showing north dike of Ash Pond #1 dry ash storage on left.**

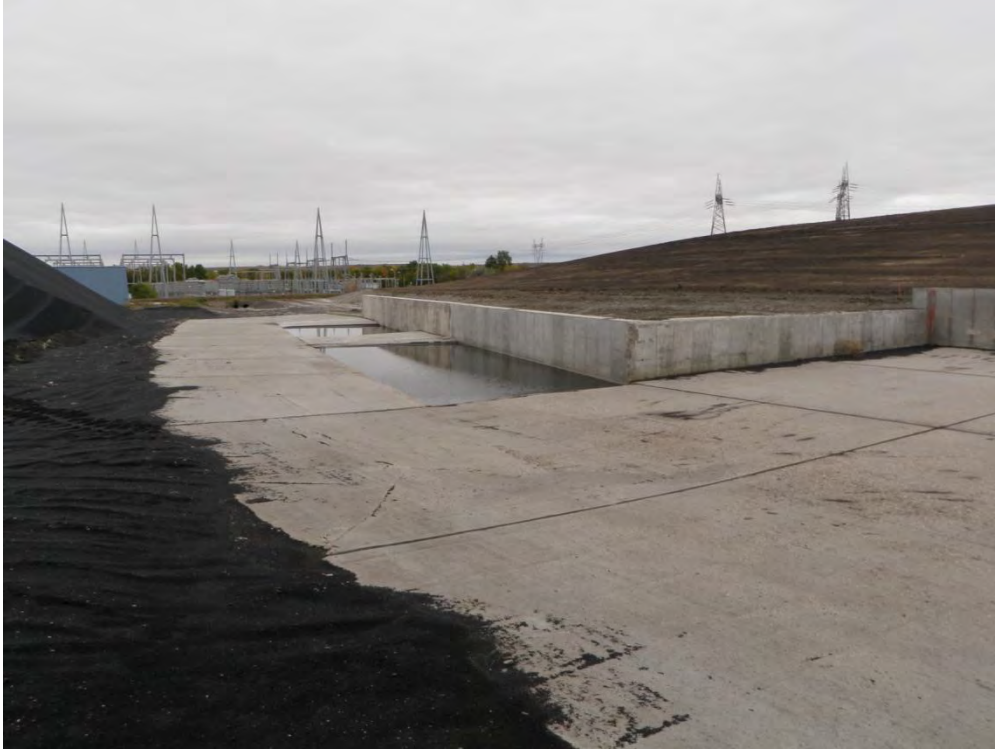
**Photo 3: Ash Pond #1: Concrete containment structure for saleable dry ash.**

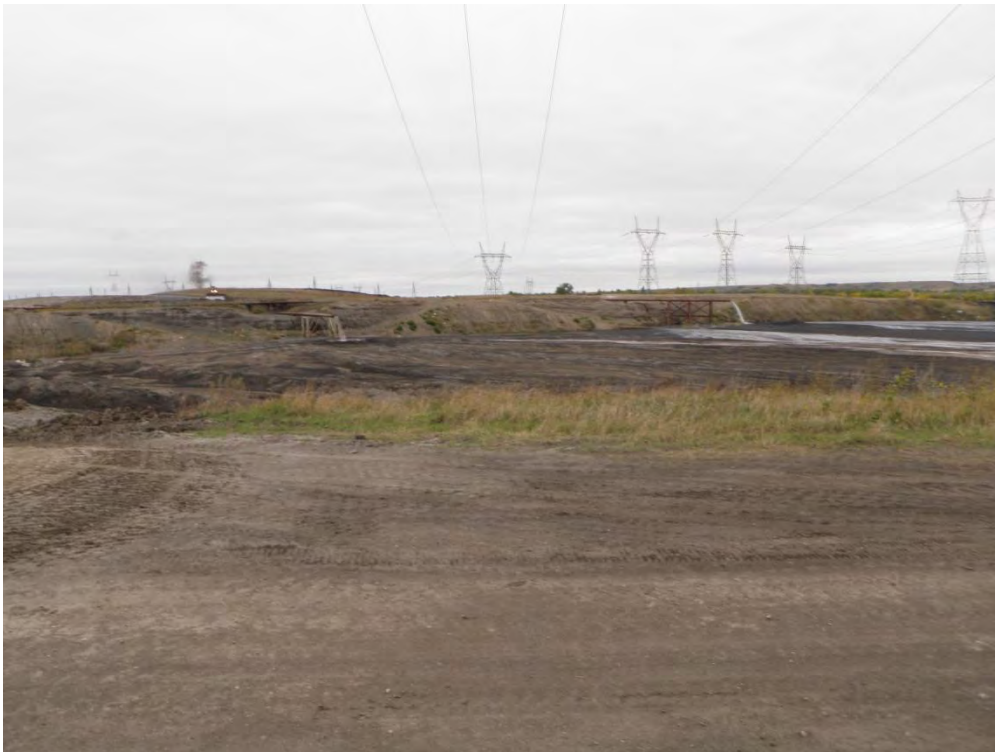
**Photo 4: Ash Pond #2: Elevated pipes sluicing ash and water from plant into pond.**

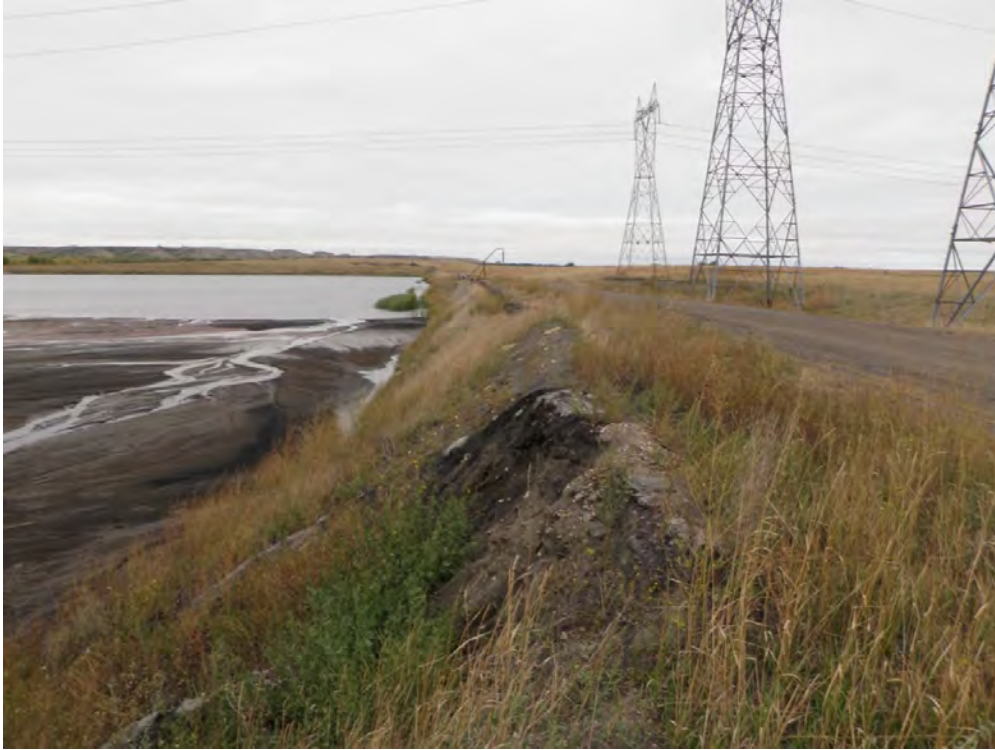
**Photo 5: Ash Pond #2 – View of south perimeter dike looking east.**

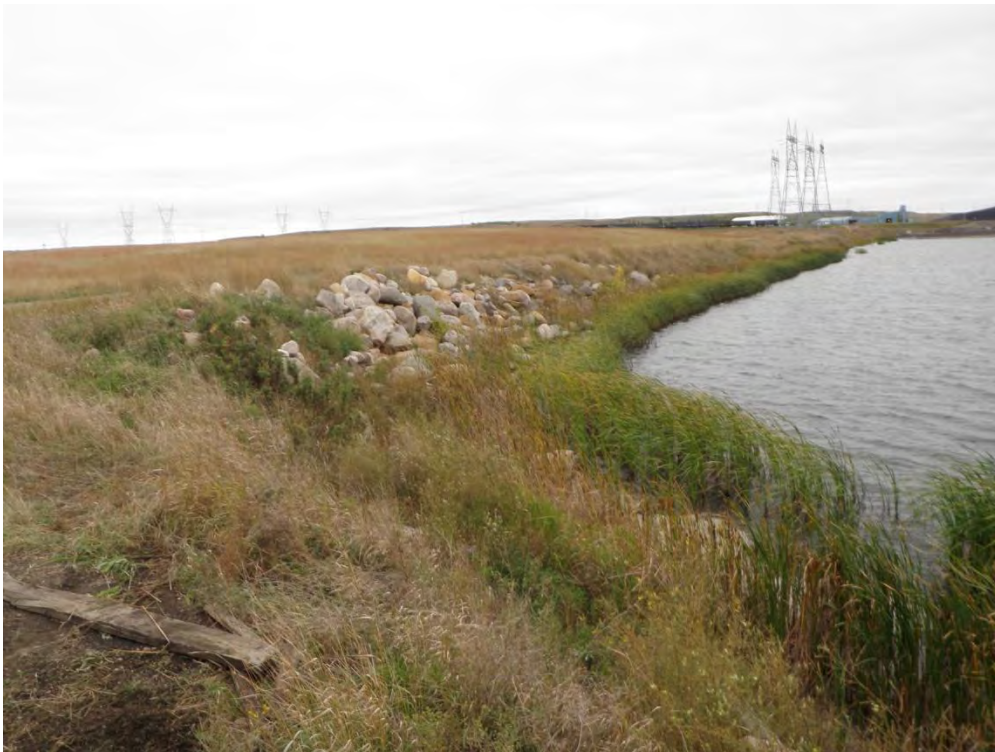
**Photo 6: Ash Pond #2 – Grassy vegetation and riprap in southeast corner of pond.**

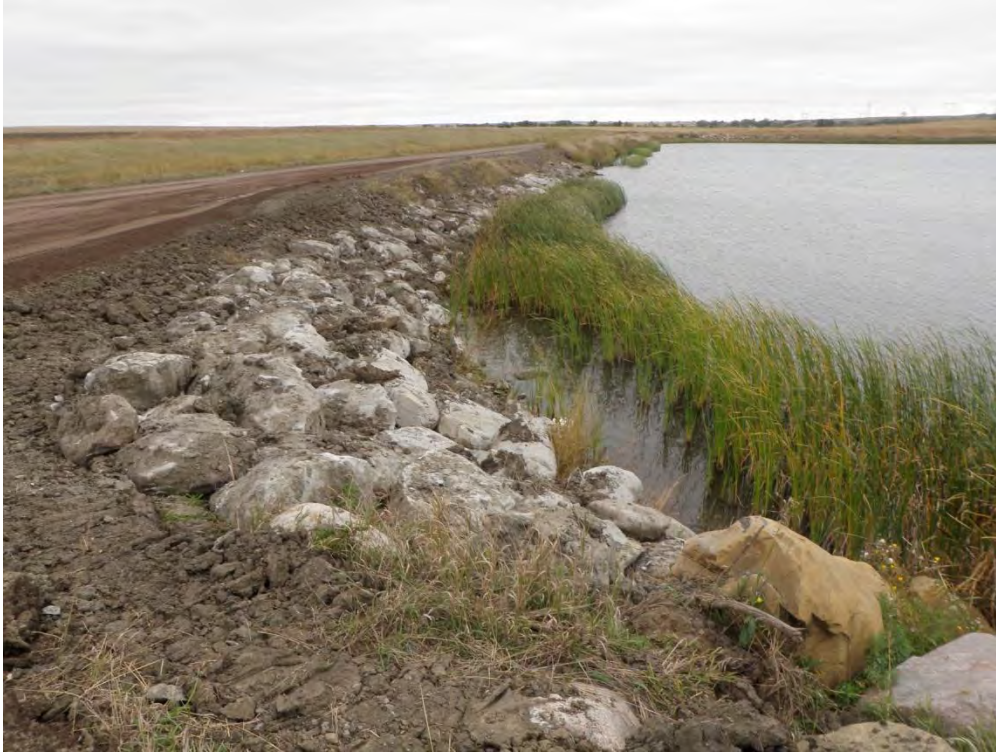
**Photo 7: Ash Pond #2 – New riprap placed in northeast corner of pond.**

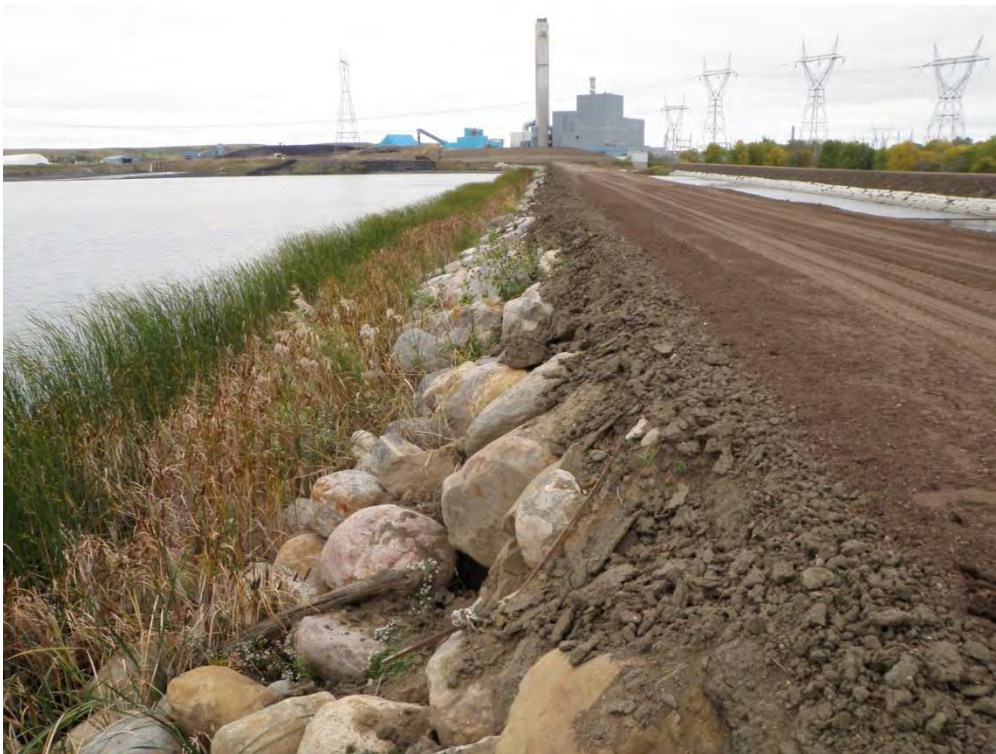
**Photo 8: Ash Pond #2 – New riprap along north dike between Ash Ponds #2 and #3. Ash Pond #3 is shown on the right.**

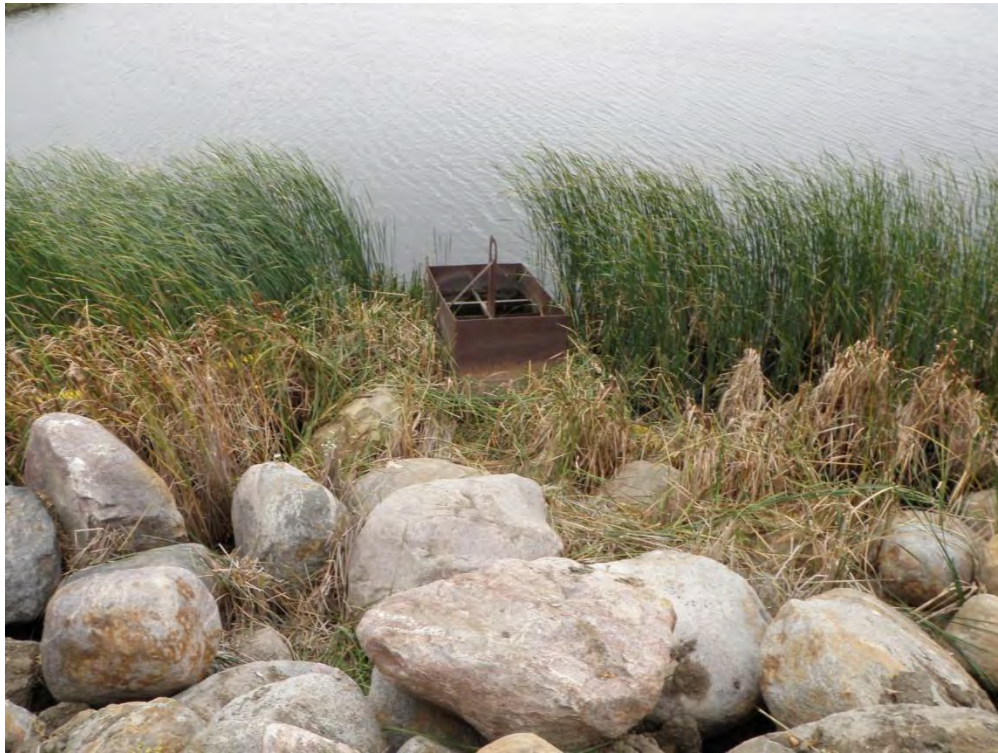
**Photo 9: Ash Pond #2 – Decant structure on outlet pipe to Ash Pond #3.**

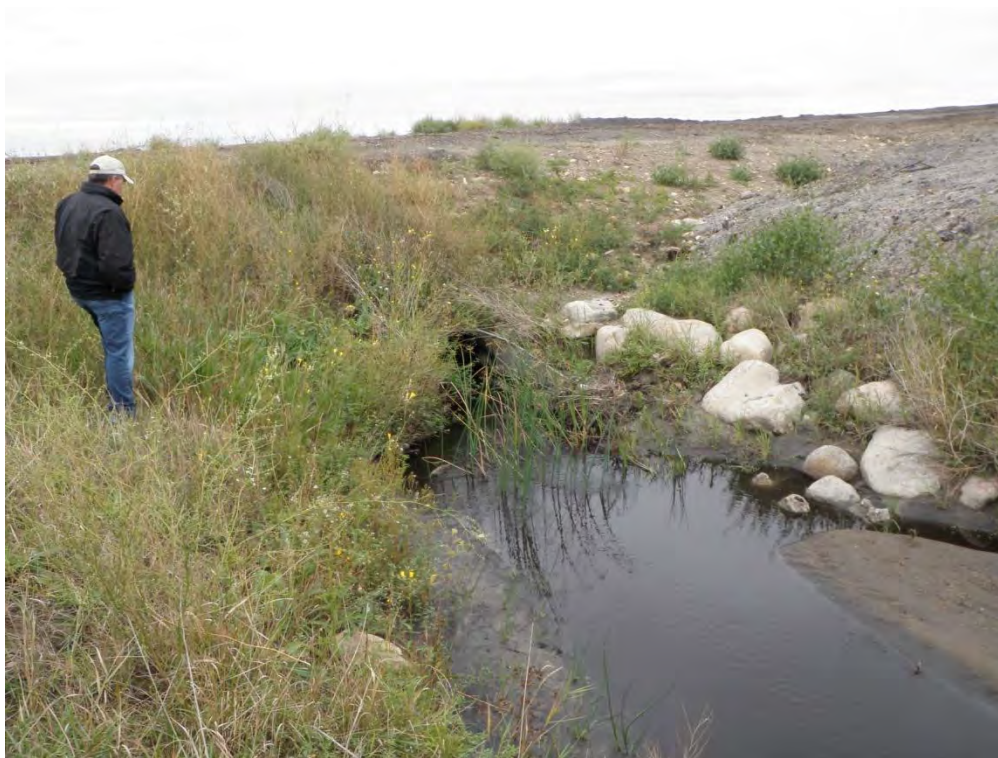
**Photo 10: Ash Pond #2 – Outlet from Coal Yard Drainage Ditch to Ash Pond #2, showing drainage ditch in foreground.**

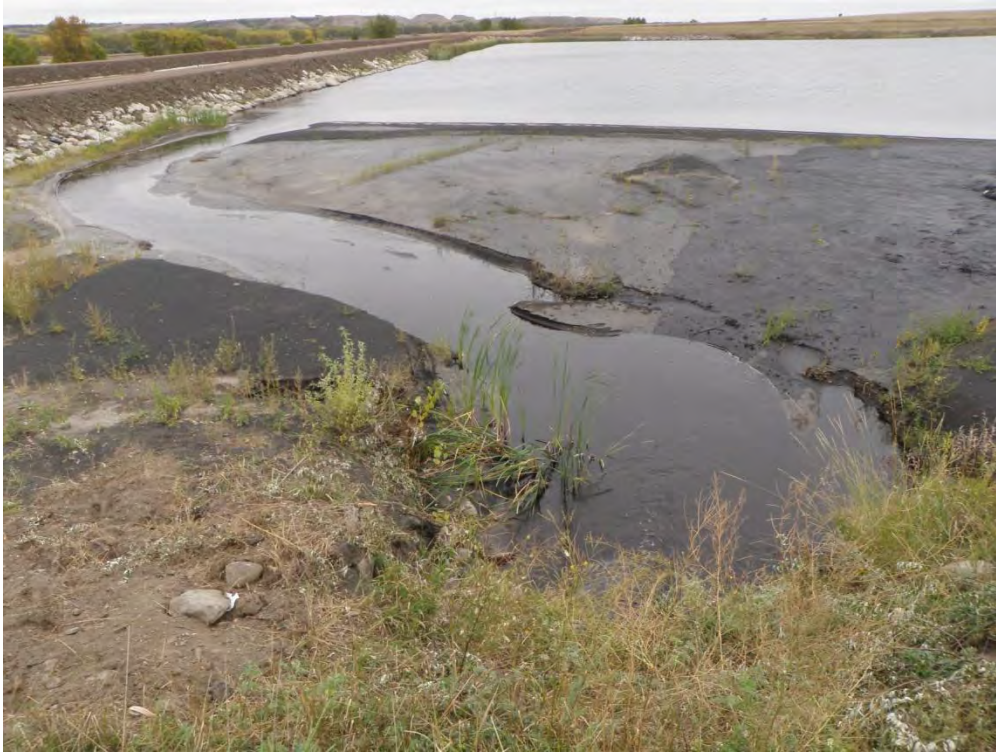
**Photo 11: Ash Pond #2 – Outlet from Coal Yard Drainage Ditch to Ash Pond #2, showing northwest corner of Ash Pond #2.**

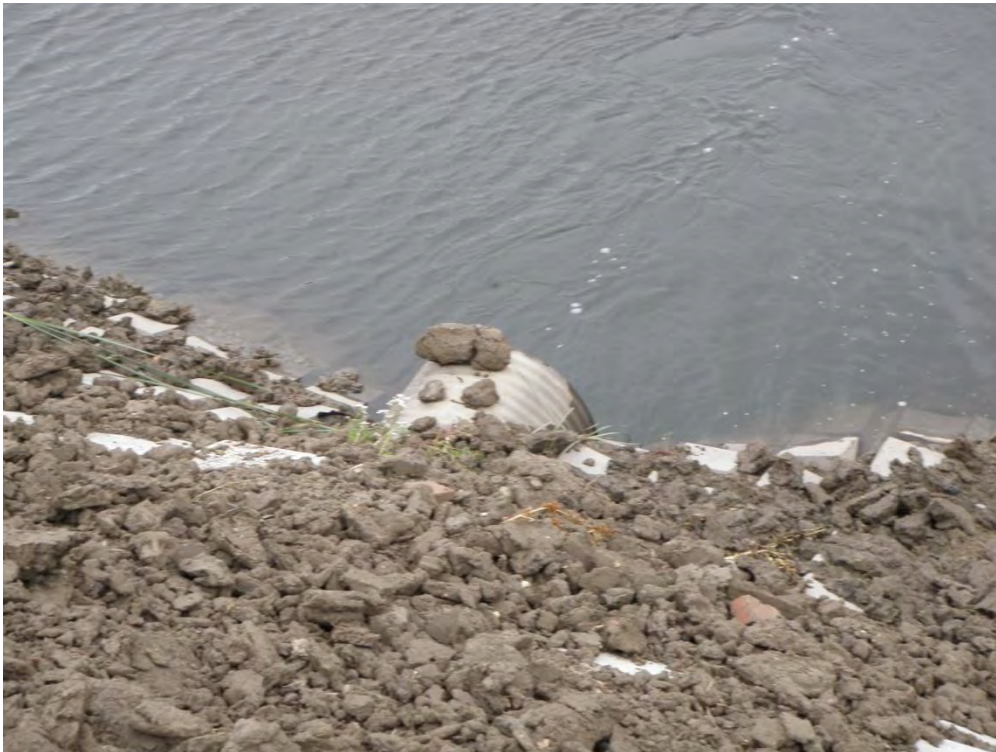
**Photo 12: Ash Pond #3 – Outlet pipe from Ash Pond #2.**

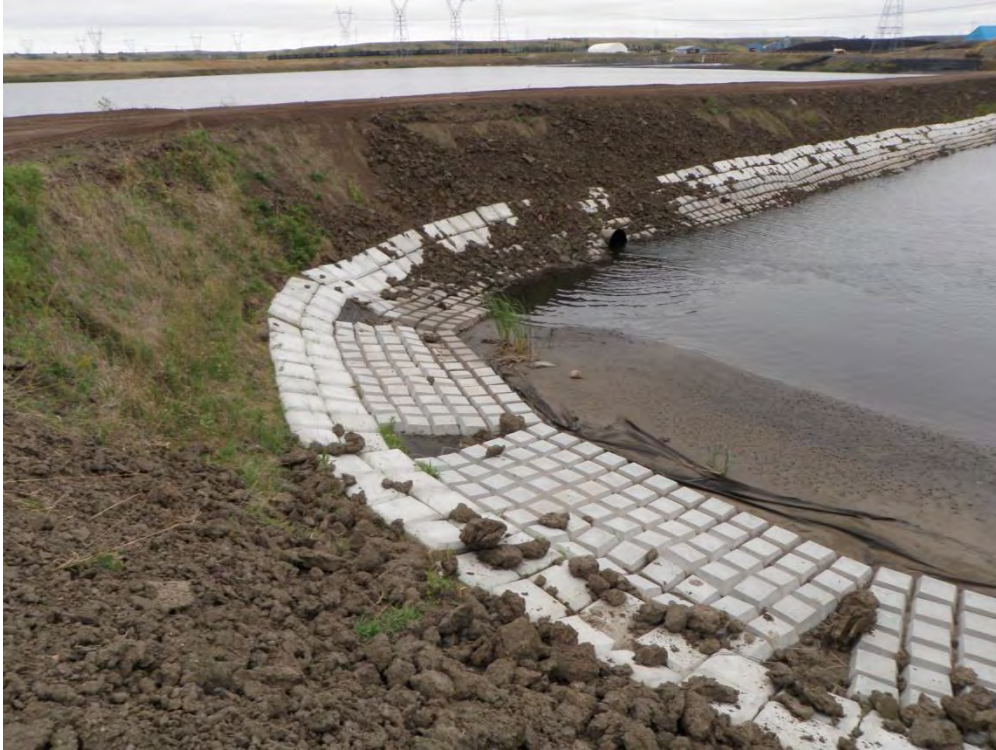
**Photo 13: Ash Pond #3 – Cellular concrete mats installed at the upstream toe of the pond.**

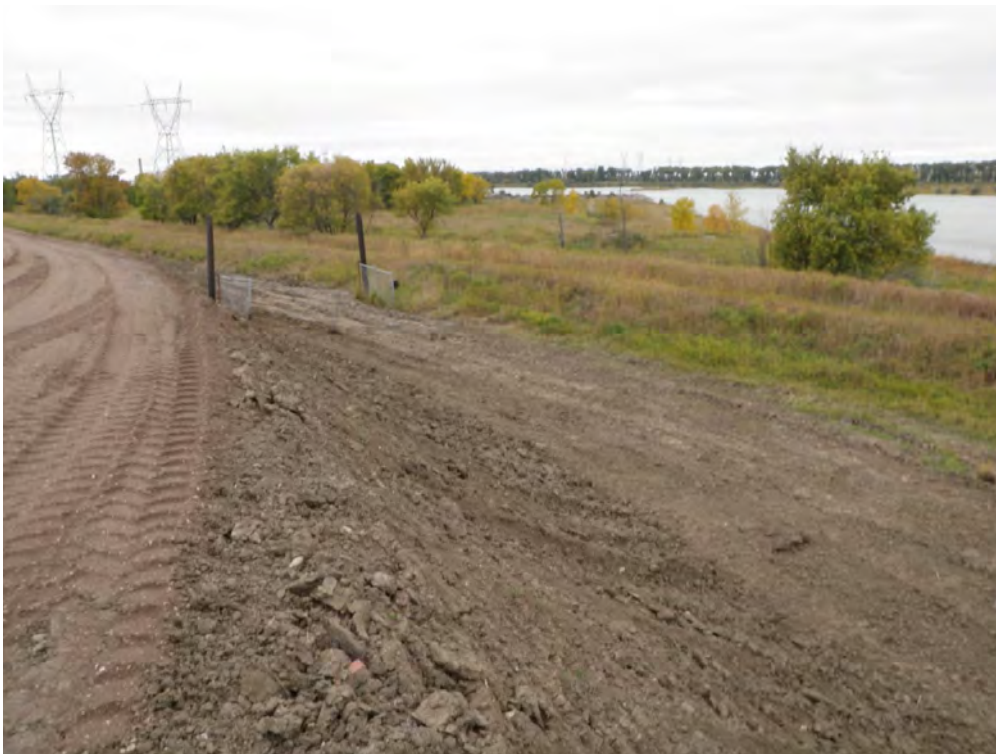
**Photo 14: Ash Pond #3 – Re-graded perimeter dike at northeast corner of pond, showing Missouri River in background.**

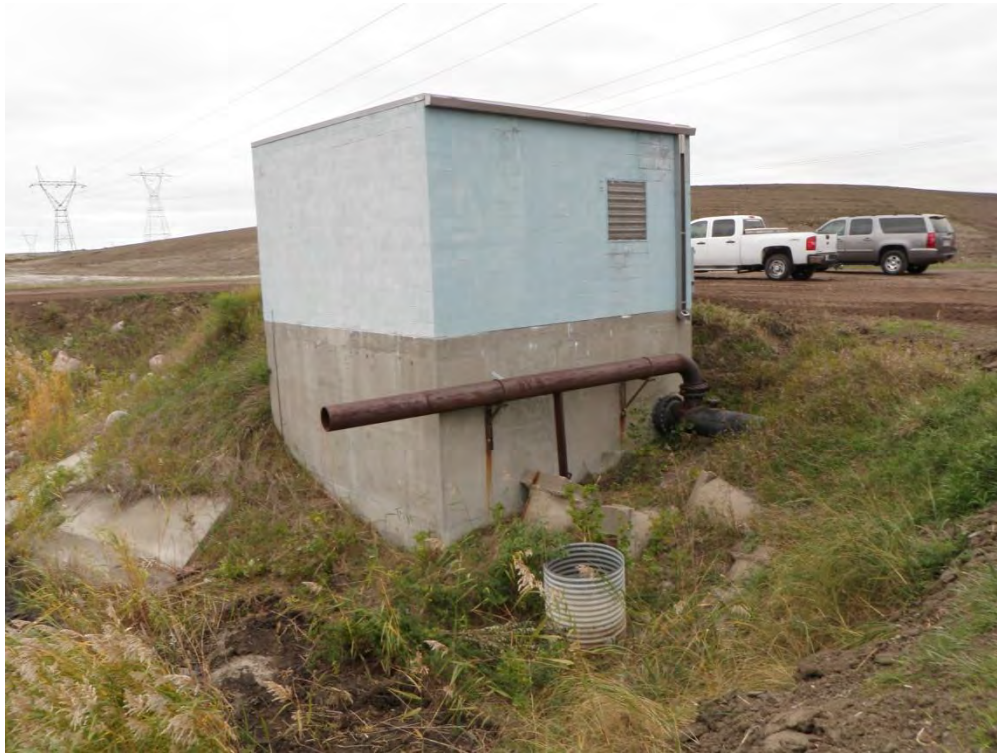
**Photo 15: Ash Pond #3 – Pumphouse at the west edge of Ash Pond #3.**

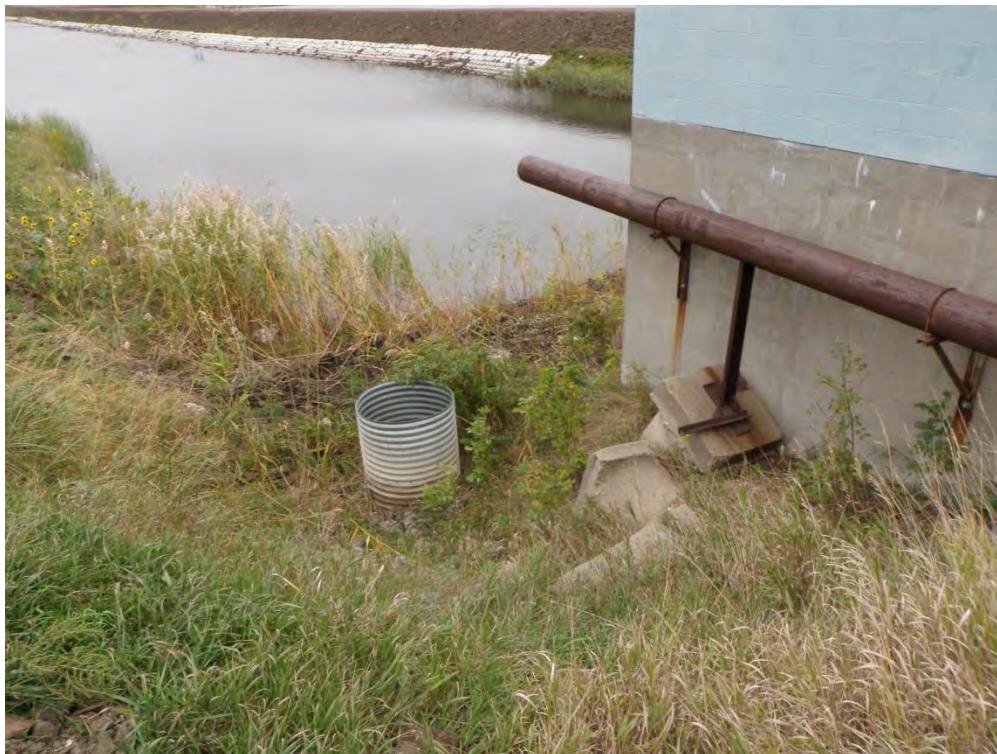
**Photo 16: Ash Pond #3 – Decommissioned riser in northwest corner of pond, adjacent to pumphouse.**
